**Calvert Cliffs Slope Erosion Project  
Phase I Final Report**

**Processes and Controls  
of Coastal Slope Erosion**

January 31, 1992

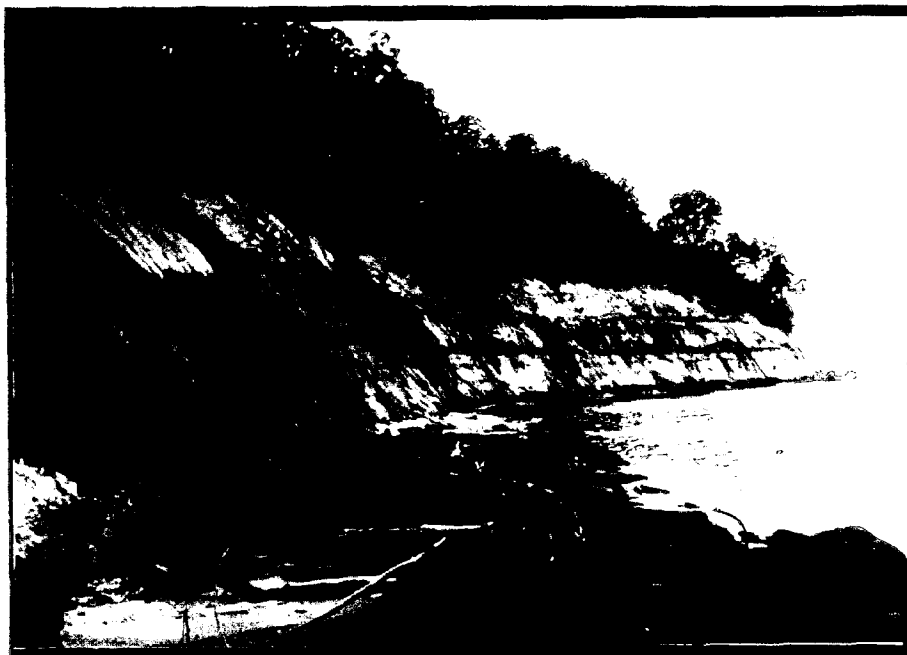
Top photograph - Calvert Cliffs State Park, Grays Creek South  
Bottom photograph - Calvert Cliffs State Park, Rocky Point

Both slopes are Type III slopes. Here, hydrologic processes control the rate of erosion in the midslope and wave undercutting controls the rate of erosion in the toe zone. The contrast between the midslope and lower slope is clear in this photo; it occurs at the change from dark to light material. Ironstone blocks can be seen in the foreground.
